Scand J Work Environ Health [1999;25\(3\):227-232](#)

Ozone-induced respiratory illness during the repair of a portland cement kiln

by [Sanderson WT](#), [Almaguer D](#), [Kirk LH III](#)

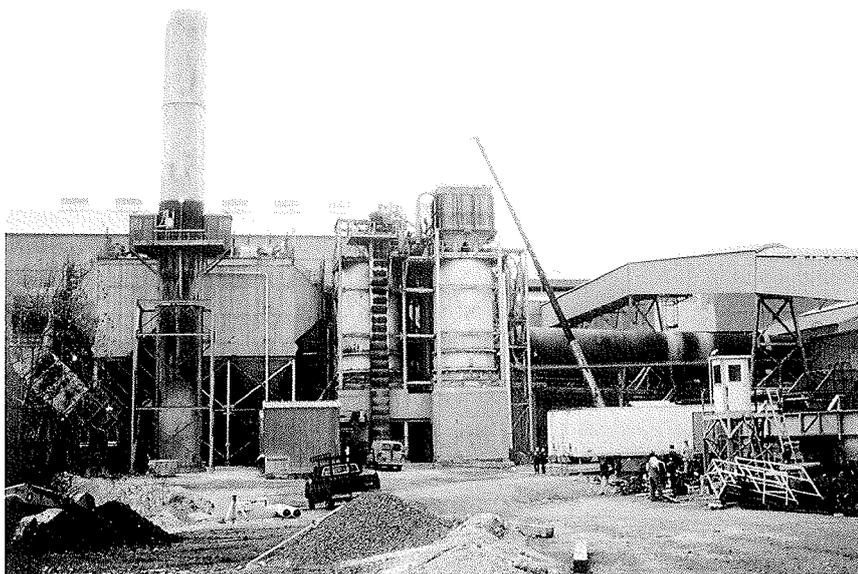
system and exhaust stack, but kiln 4, which began operation in 1970, had a separate dust control system and exhaust stack. In 1995, the height of the exhaust stacks was increased due to excessive, in-plant sulfur dioxide exposures from the combustion of coal in the kilns. Since that time no further problems with excessive sulfur dioxide exposure have been reported. Figure 1 shows the exhaust stack and electrostatic precipitators at the inlet end of kiln number 4.

Figure 1. Back end of kiln number 4 showing exhaust stack and electrostatic precipitators.

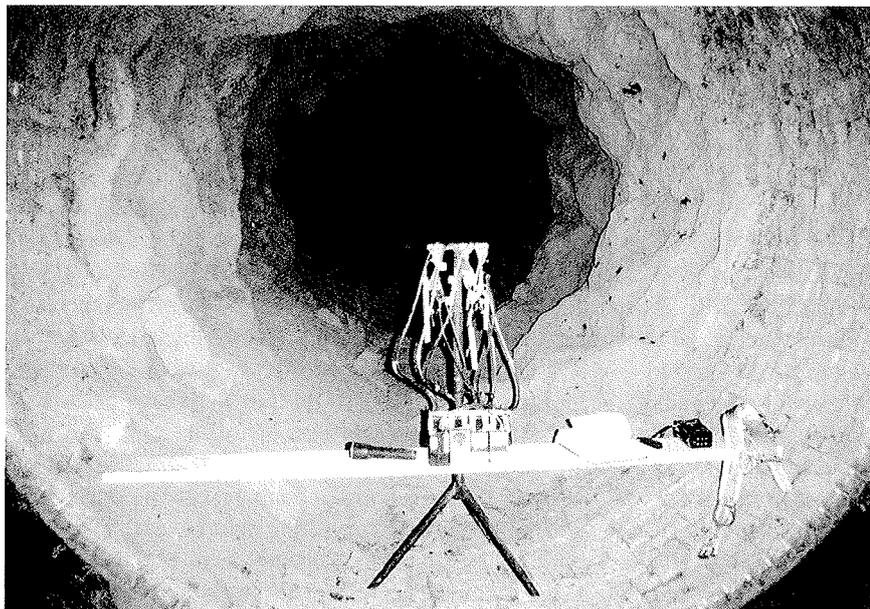
Area samples were collected for chlorine, inorganic acid, sulfur dioxide, respirable, and total dust by attaching sampling media to tripods positioned near the front, middle, and rear of the kiln (figure 2) (5). Short-term samples for ozone were collected frequently at various locations inside the kiln, using direct-reading color indicator tubes and a Metrosonic Toxic Gas Monitor™ direct-reading monitor. Since a bleach-like odor had been

Figure 2. Area sampling station inside the front end of kiln number 4.
